**Flow Regimes - Natural Extremes or Man-Made Moderation**

**Skirden Beck, Bolton-By-Bowland, Clitheroe, Lancashire.**

**23 May 2008**

**What was there, what we did, did it work ?.**

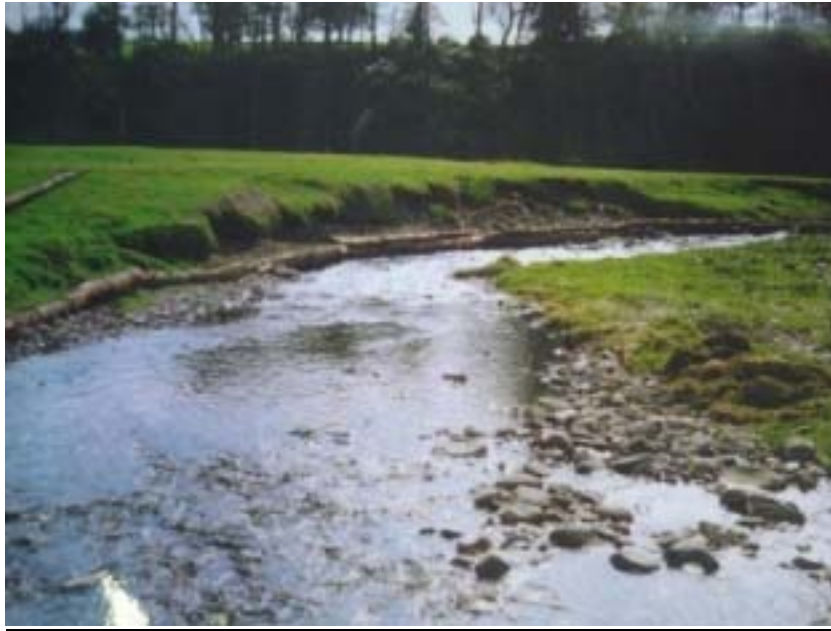
Showing commencement of log bank support on an eroding bank.

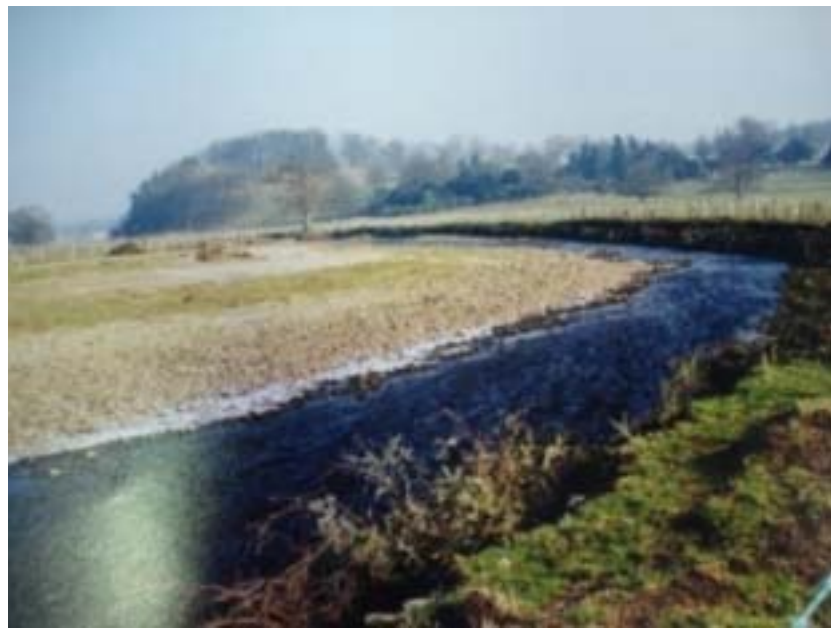
Showing initial fencing on the lower reaches with log and brush .

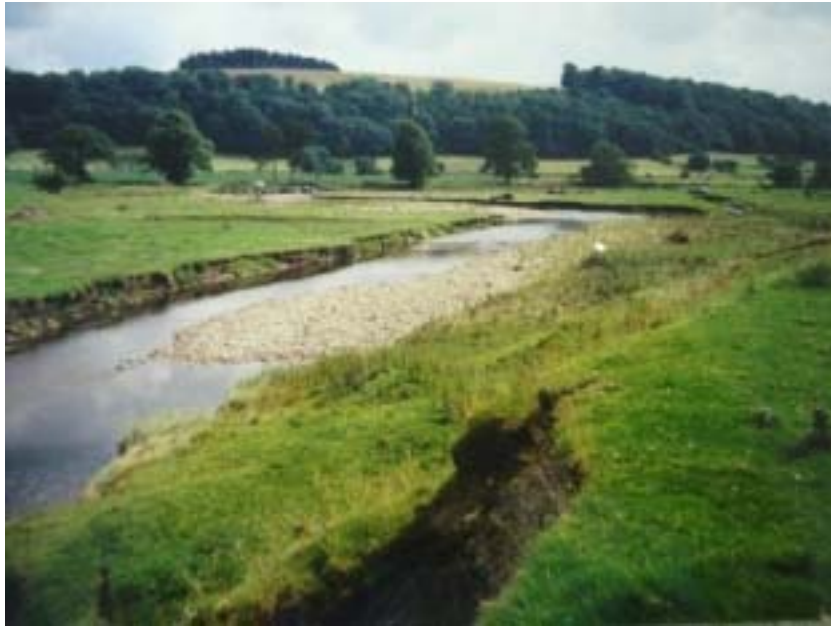
Showing unfenced, badly eroding banks.

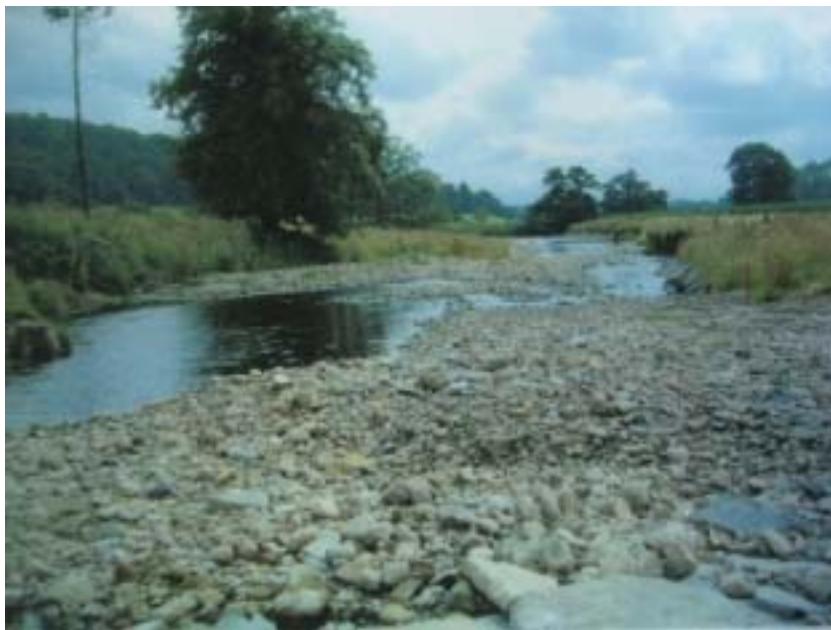
Showing eroding banks with rock armour in place on the right bank. The tree in the left foreground will later become a victim of the floods.

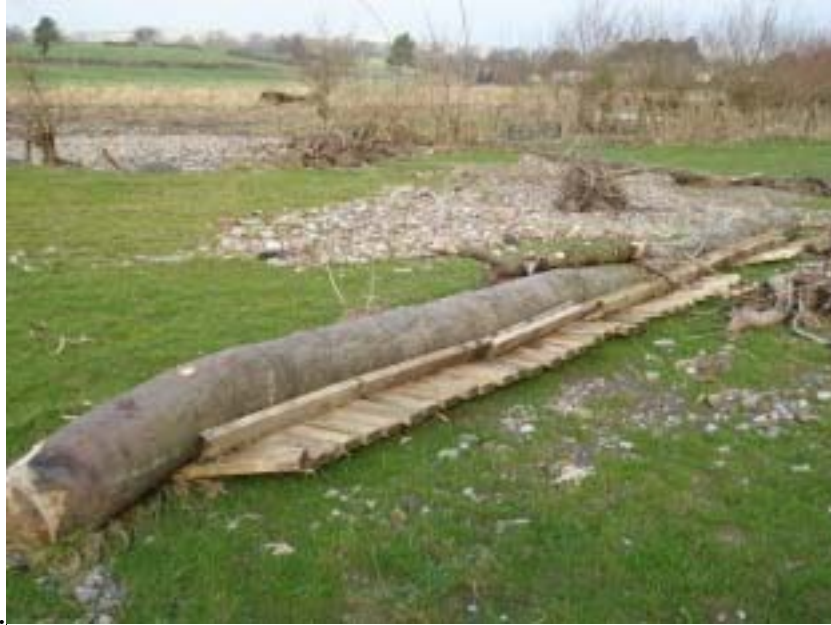
This 27ft tree trunk flood gate (not ours ! ) was washed down in a flood, large trees are regularly brought down by floods from the heavily wooded banks at the top of the stream catchment.

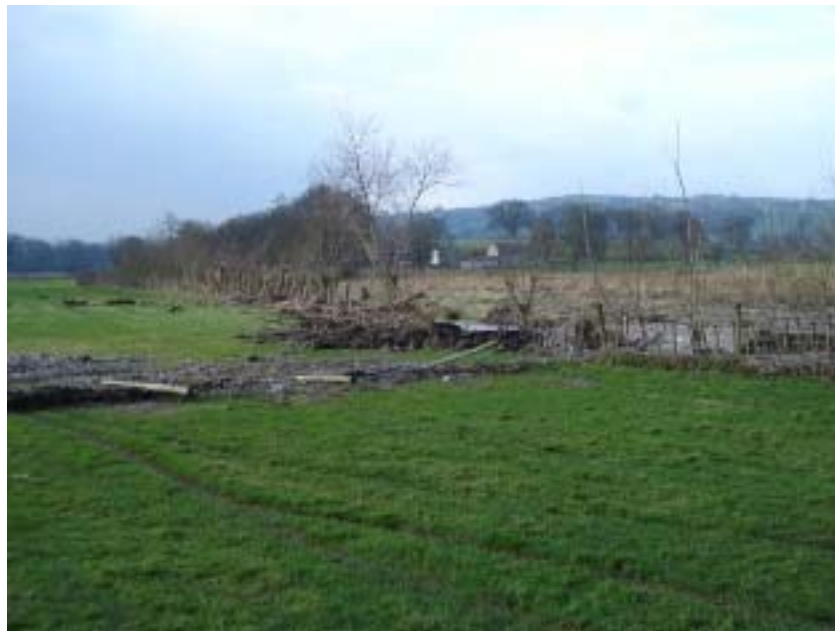
Showing where the trunk broke through the fencing.

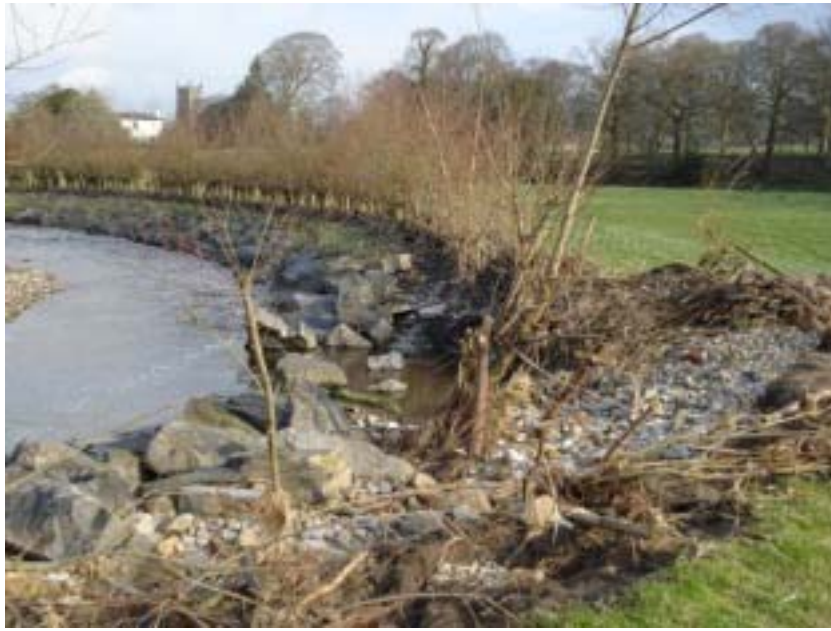
Showing where the trunk broke through the rock armour which had been in place for 6 years.

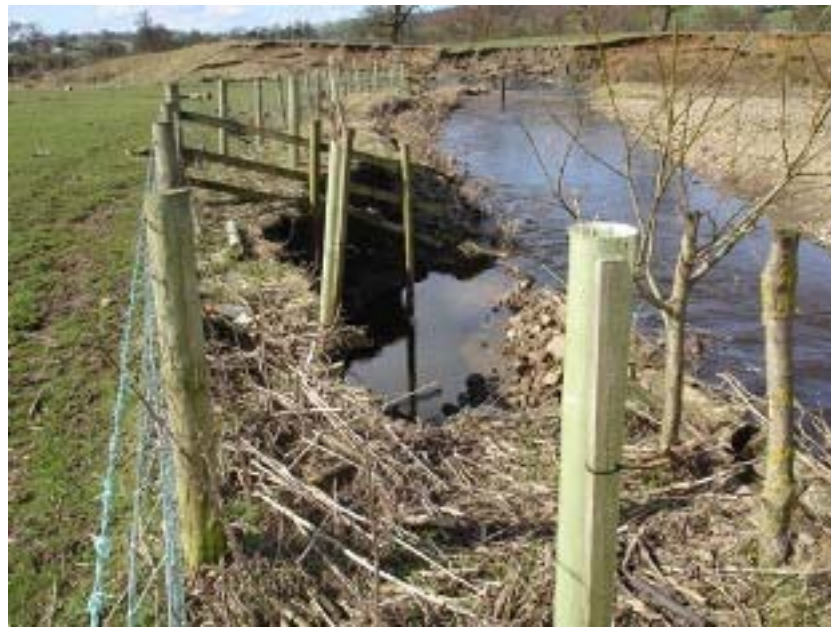
Erosion starting behind log support work. Note the tree, top centre in line with the log work. April 06.

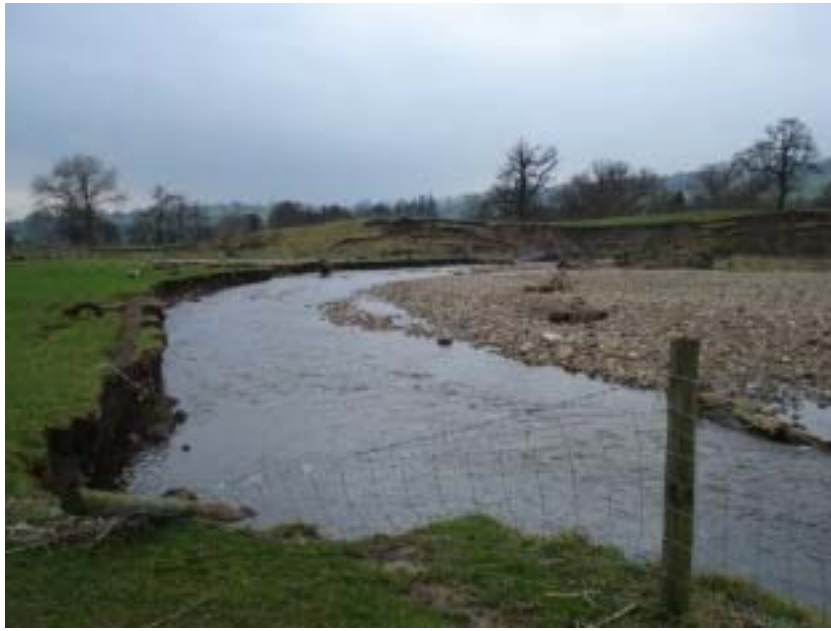
Same picture taken in February 08 ! The logs haven't moved but the bank has retreated approx 40ft!

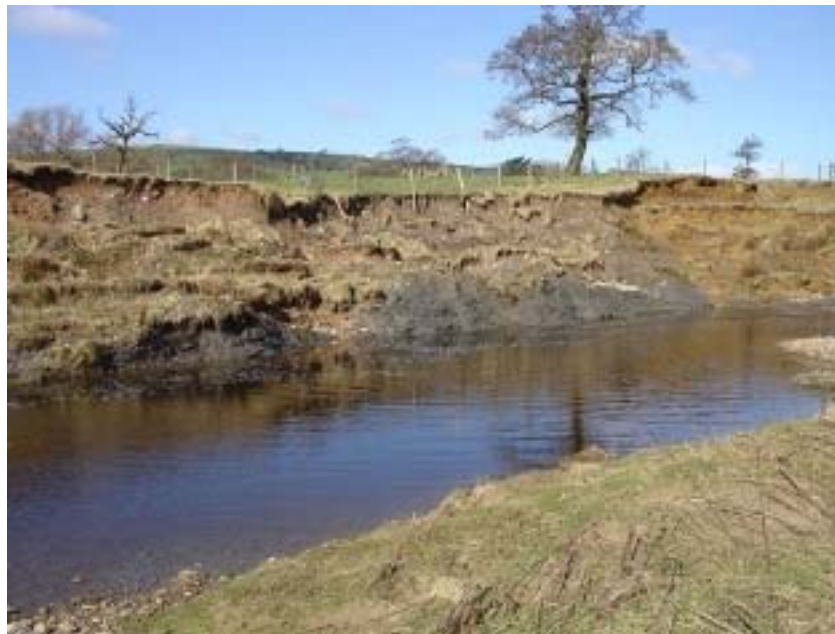
Top ground breaking away and sliding into the beck over the clay base.

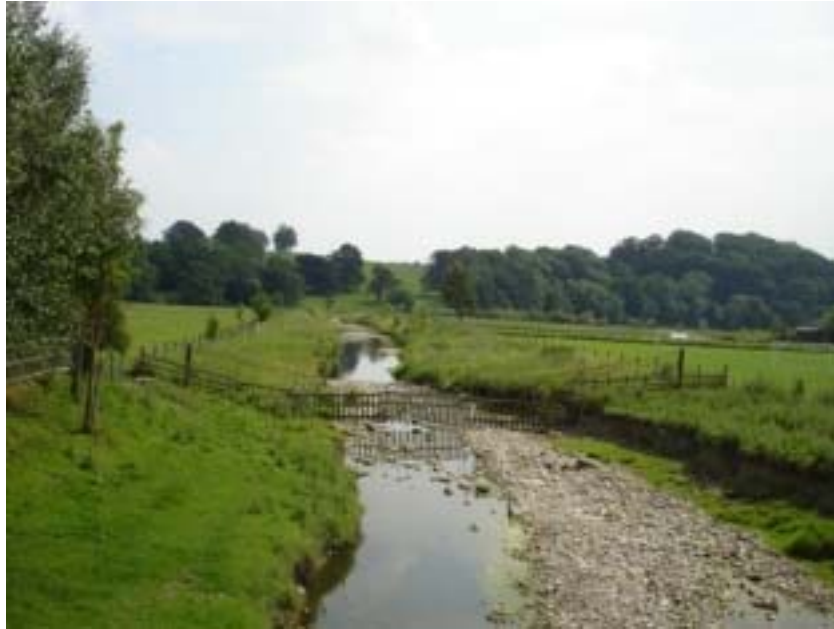
Showing the unfenced area with stock access adjoining the regenerating fenced area beyond the flood gate.

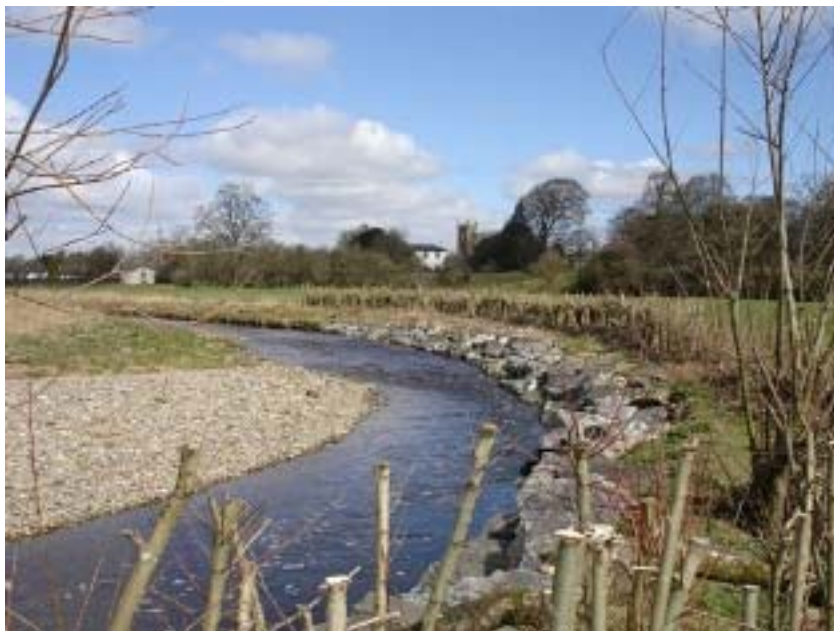
Stable rock work with coppiced willows inside the fence line.

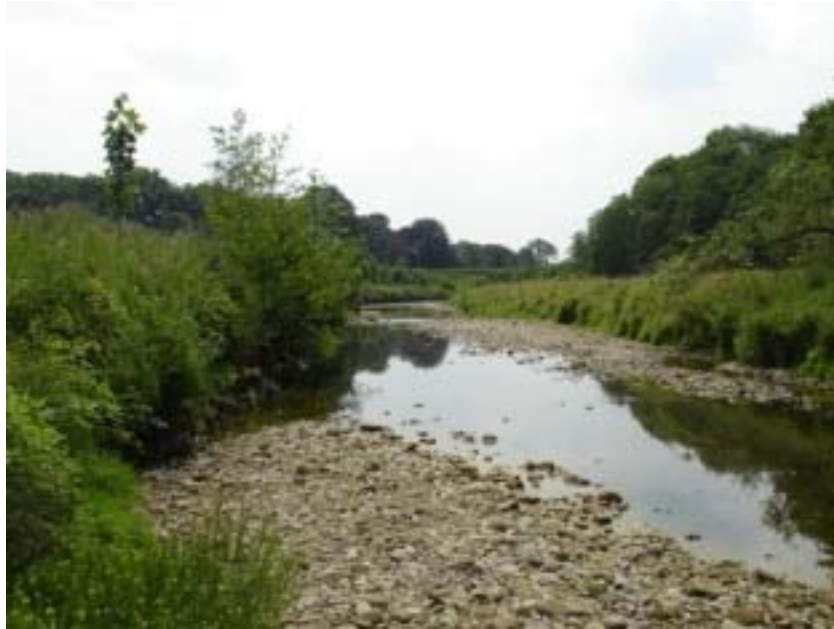
Regenerated growth on both banks inside the fence line.

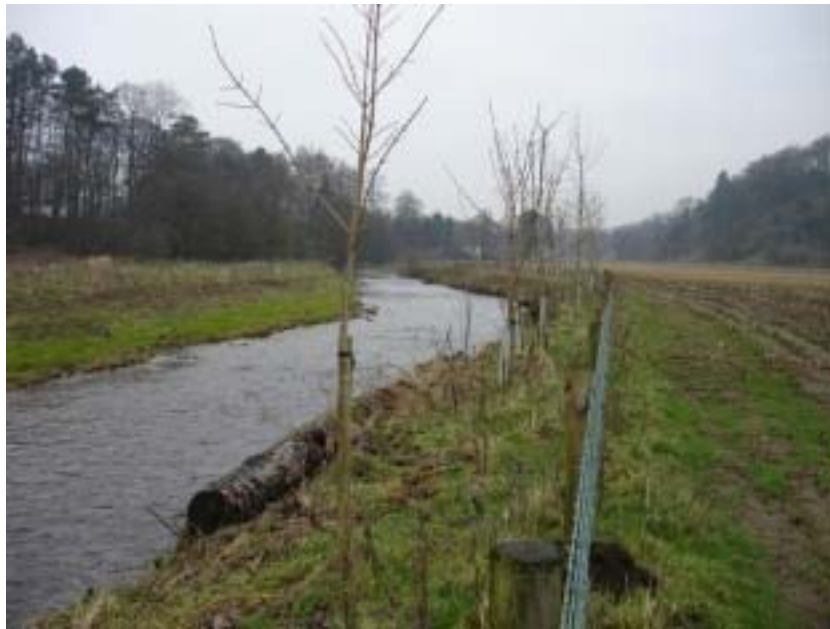
Stable log support work and established trees inside the fence line.
